1st International Conference on Structural Integrity

Old Bridges in Madeira Island – Identification and Diagnostic

José Santos^{a*}, Fábio Rodrigues^b

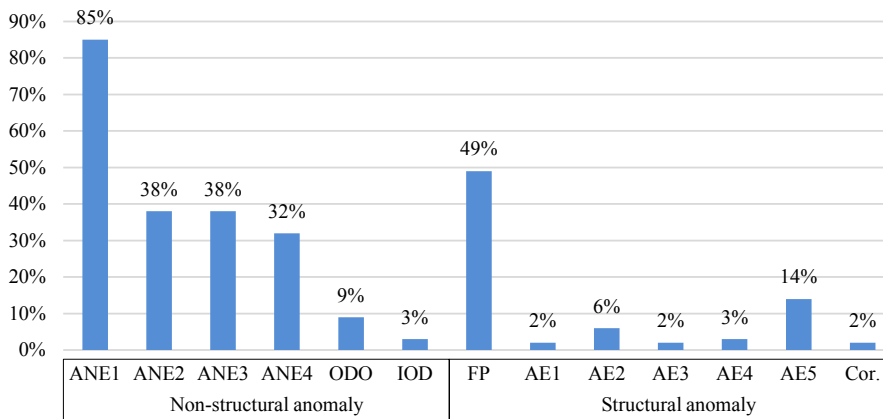
Fig. 6. Percentage of bridges by anomaly.

Fig. 6 shows the percentage of bridges with specific anomaly. It was found that 85% of the studied structures presents non-structural anomalies, being the most common anomalies: the presence of vegetation and biological pollution (ANE1 - 85%), presence of water or humidity (ANE2 - 38%), mortar loss in joints (ANE3 - 38%) and the degradation of stone material (ANE4 - 32%).

With regard to structural anomalies these are fortunately much rarer, emphasizing the cracking in the pavement (FP - 49%), detachment and rupture of elements (AE5 - 14%) and longitudinal and transverse cracks (AE2 - 6 %). It was found that the source of these anomalies was due to the lack of periodic maintenance and excessive loads to which these bridges were subjected.

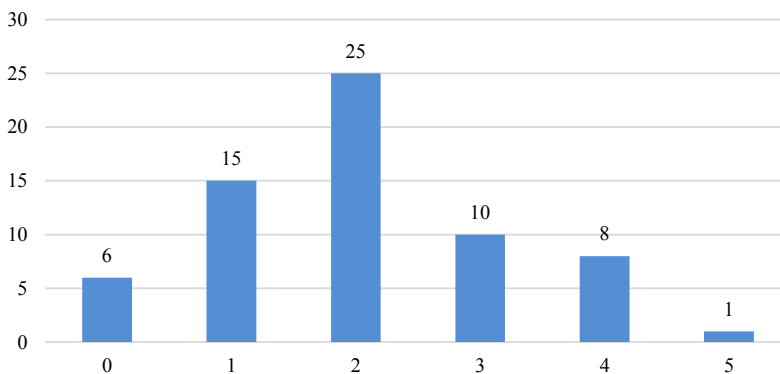
Fig. 7. Number of bridges by conservation state.

Fig. 7 shows the distribution global conservation state observed in 65 bridges analysed. The most common conservation states of the bridges are of type 1 and 2. For these classifications Table 1 indicates the need for non-priority repairs, but some maintenance should be performed in order to assure the durability and the behaviour of the structures. The types 3 and 4 (18 bridges) do not refer to structural problems, but the absence of guardrails. A rating of 5 was assigned a currently inactive bridge.

With regard to the analysis of the conservation state it was observed that the conservation state prevailing in these structures are of type 1 and 2, thus indicating the need for non-priority rehabilitation interventions in the medium and long term. Bridges with type 3 and 4 do not present structural problems, but lack of guardrails.
