2nd International Conference on Structural Integrity, ICSI 2017, 4-7 September 2017, Funchal, Madeira, Portugal

Low durability of concrete elements due to steel corrosion – cases wherein the steel reinforcing bars acted as an internal clock bomb

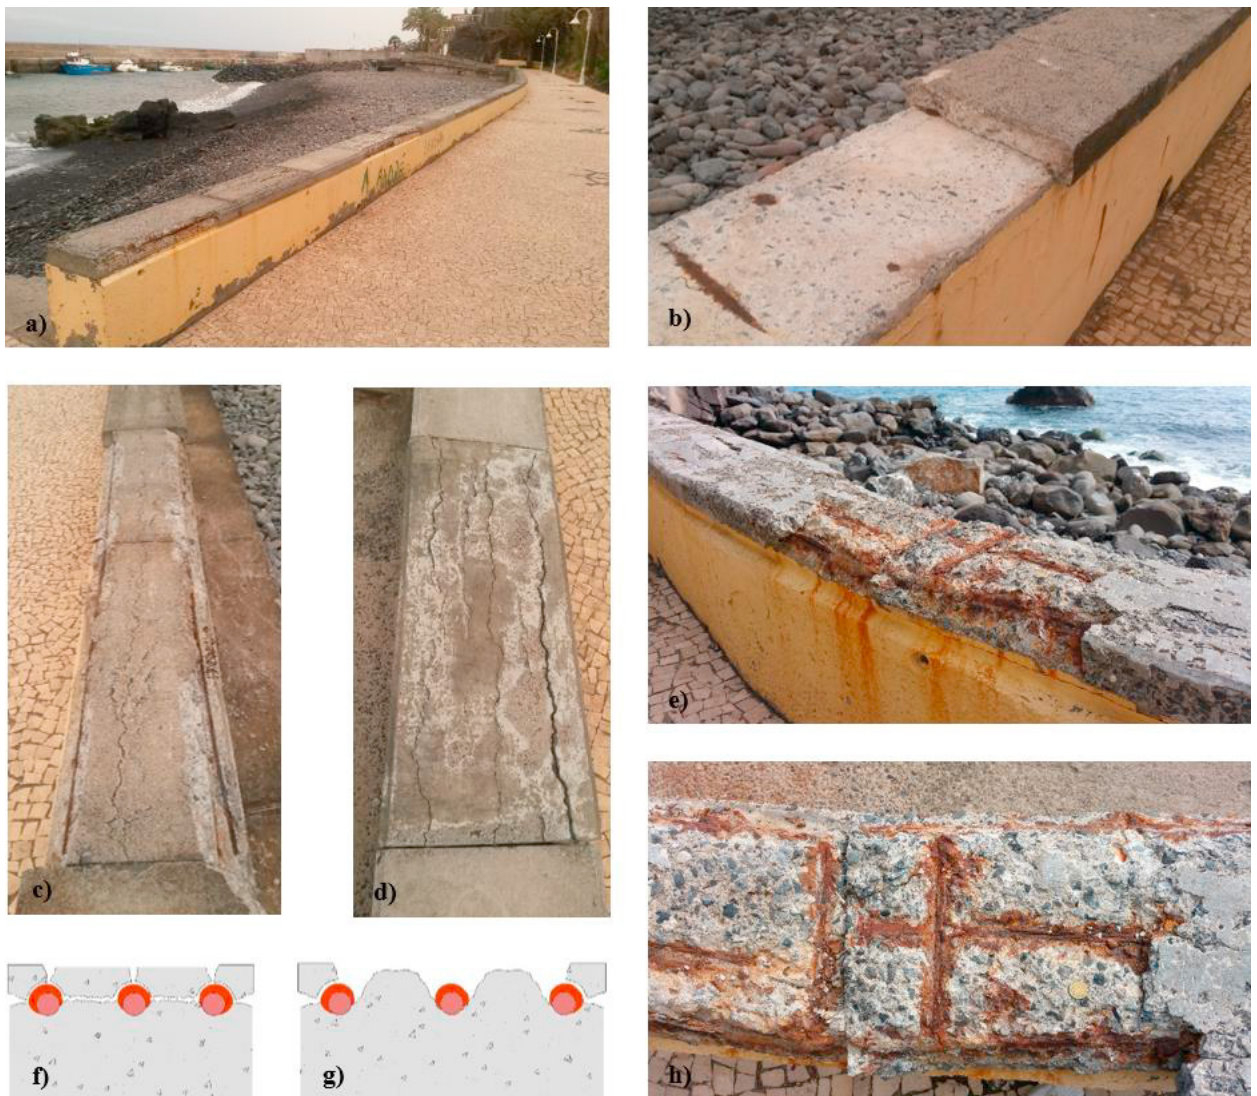
Figure 2. Fence / sitting concrete wall: a) Element overview; b) Construction with two distinct elements; c) Spalling of edges; d) Advanced cracking of the prefabricated element (cover); e) Full corrosion and delamination of the cover (not prefabricated); f, g) Scheme of the reinforcement corrosion and consequent cracking and delamination; h) Detail of the deterioration of the cover in the no prefabricated element.

The first example is a typical (in the Madeira Island) concrete wall that function also as a fence and as a sitting between the promenade and the beach (Figure 2.a)). It can be made in a single element poured in situ (Figure 2.e)) or made by two elements with the wall poured in situ and with a prefabricated element in the top (Figure 2.b)). In this type of concrete elements, possibly, the reinforcement would be structurally unnecessary – it looks to be a gravity wall. Perhaps rebars were placed to control shrinkage or due to transport (in the prefabricated elements), but no anticorrosive cares were ensured. Probably this infrastructure would be in a better condition if there was no steel rebars. The reality is: steel rebars got corroded and destroyed the concrete element – they acted as an internal clock bomb! No reinforcement or GFRP rebars should be the correct solution. If steel rebars are used, even if they are just temporarily for the construction (not structurally), corrosion should be prevented.

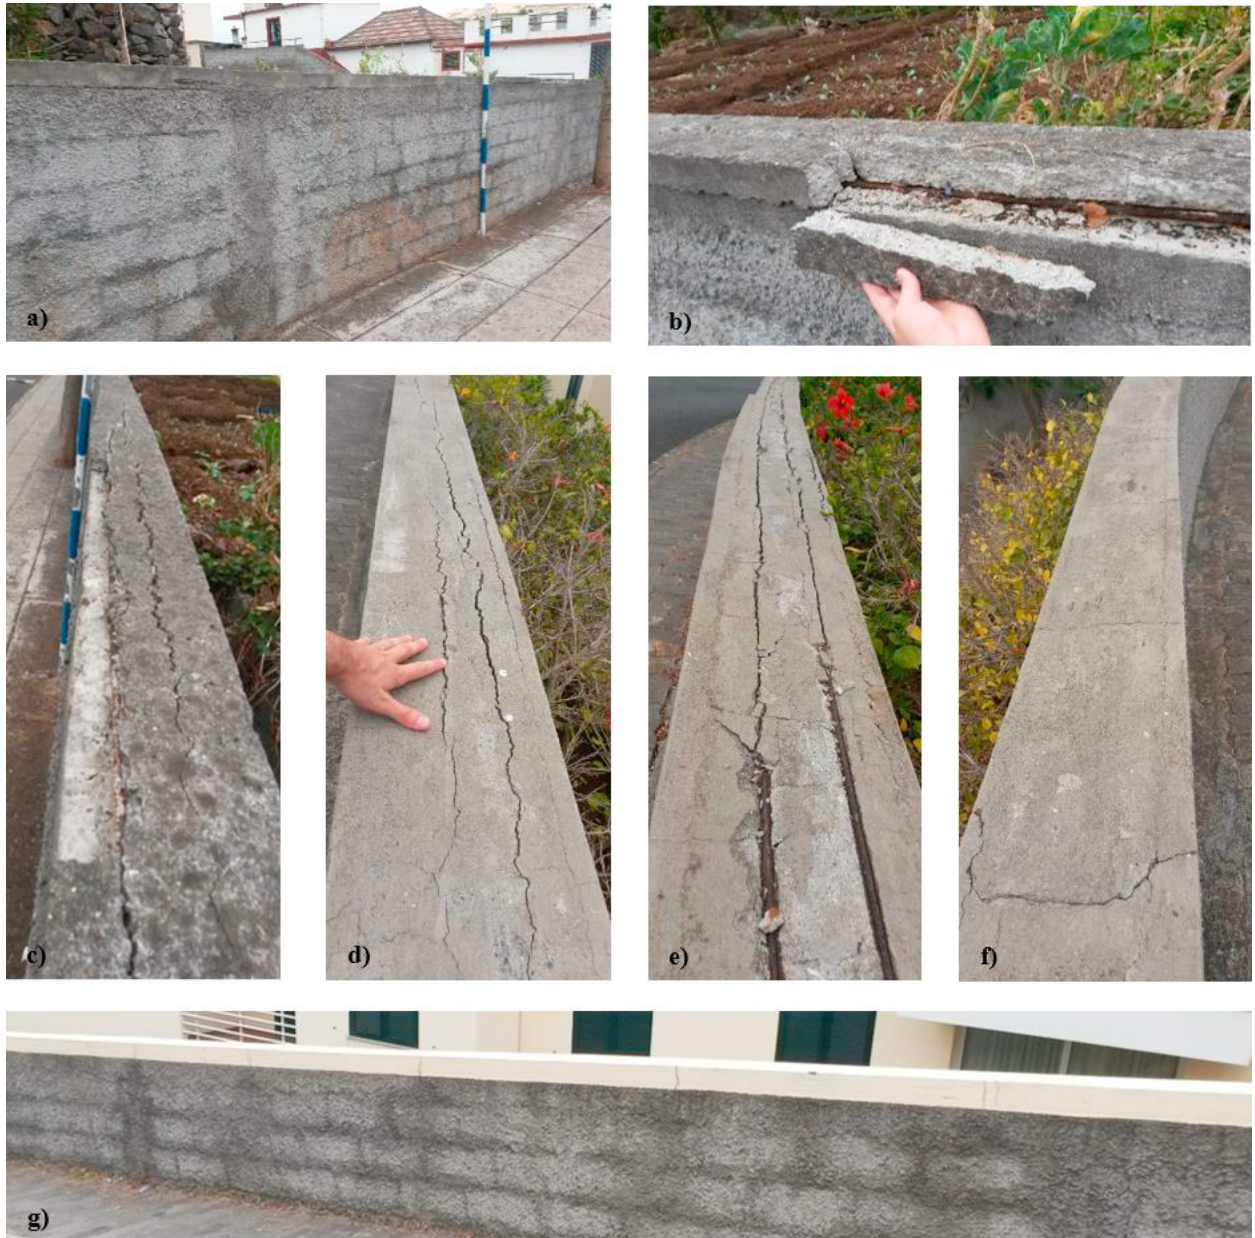
Figure 3. Concrete block wall with mortar at the top: a) Element overview; b) Detail of the spalling of edges; c) Advanced cracking and spalling of edges; d) Cracking part; e) Cracking over corroded rebar; f) Detail of the transversal cracking not avoided g) Alternative concrete block wall having transversal cracking but no corrosion and longitudinal cracking.

Block concrete walls are being worldwide used. However, it become a typical construction practice in Madeira Island to place at the top of the wall about 5 to 10 cm of mortar with two steel rebar (having 10 mm of diameter) – see Figure 3. These two steel rebars are just placed inside the mortar without no especially care. It is a bad construction practice (that is even not able to prevent the transversal cracking – Figure 3.f) that leads to the steel rebars to act as a clock bomb into the mortar (Figure 3. b),c),d),e)). Note: mortar is a material with high permeability. No reinforcement would be the best solution with the transversal cracking being perfectly accepted (Figure 3.g)).

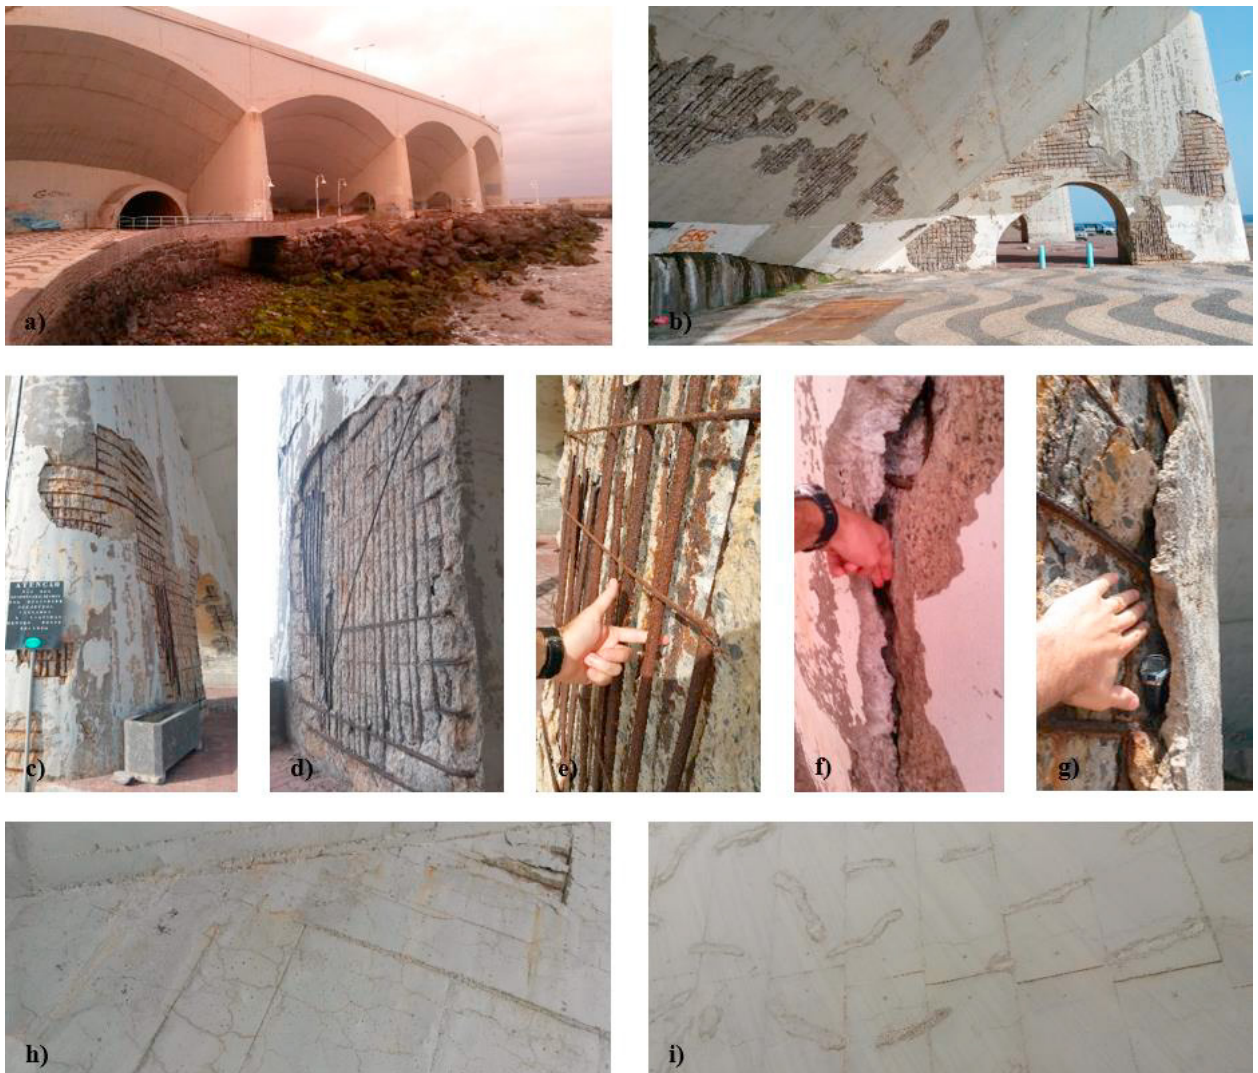
Figure 5. Concrete buttress arch: a) Construction overview; b) Generalized spalling; c) Buttress; d) Advanced spalling with disappearing of the rebars; e) Disassemble of the steel rebars; f), g) Gaps between the cover and buttress core; h) Overall cracking; i) Repairing points.

At the end of the runway of the Cristiano Ronaldo Airport (in the Madeira Island) there a highway which is supported by a concrete buttress arches (Figure 5.a)), being the sea just a few meters behind. Looking close at the construction it can be observed corrosion overall the structure. In some elements, especially in a buttress delamination is generalized (Figure 5.b),c,d),e),f),g)), some rebars having already disappeared or separated from the concrete core (Figure 5.d),e)). The arches show overall cracking (Figure 5.h)), although some parts have been already repaired (Figure 5.i)). Looking at the structure it is not possible to affirm that rebars were unnecessary (if they were placed just for shrinkage or if they were structurally required). But, the point is: not only rebars are already not there (that means that at the moment rebars are not function as structural), but also the concrete section was markedly reduced (more than 10 cm of cover has disappeared due to delamination). Observing the concrete one perceives that concrete has high permeability and incorporates aggregates with about 5 cm. There was no construction care to prevent the steel rebars corrosion - it was like to put a clock bomb inside the concrete. Being a such important structure, the solution could be: i) to use a concrete with very low permeability (including very low cracking), ii) to apply stainless steel rebars, iii) to apply GFRP rebars, iv) (if possible) to apply plain concrete.

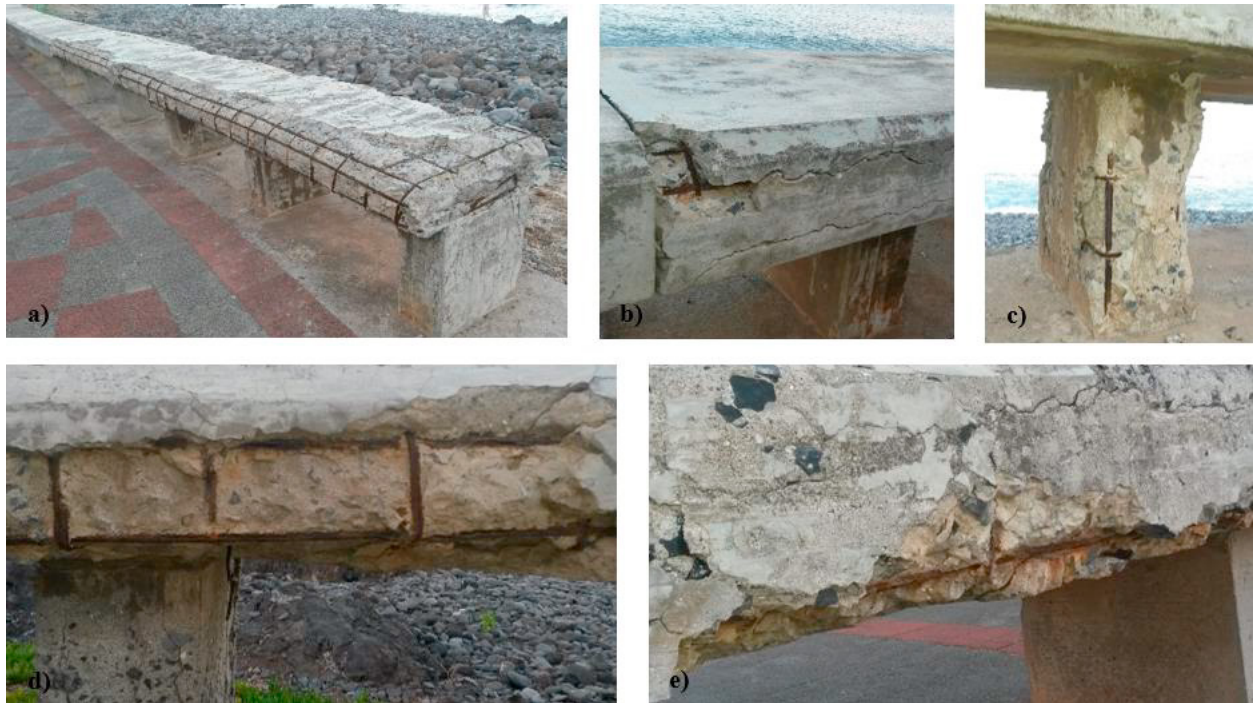
Figure 6. Fence / concrete bench: a) Element overview with delamination in the edges; b) Detail of cracking and spalling; c) Detail of a support with spalling on the edges; d) Detail of the concrete and the steel rebars disappeared; e) Detail of the aggregates dimension of the concrete.

Lastly, it is presented a concrete bench that function as a sitting between the promenade and the beach (Figure 6.a)). Looking at Figure 6 it seems that reinforcement was structurally unnecessary because the structure looks quite rigid due to its geometric shape. Probably, rebars were placed to control shrinkage or to respect codes. But, seeing Figure 6.b),c),d),e) it is clear that concrete is too bad and it has aggregates too large to ensure low permeability to protected the steel rebars – as rebars were not structural, no protection to corrosion was ensured. Thus, steel rebars acted as an internal clock bomb as they got corroded! No reinforcement or GFRP rebars should be a more appropriate solution.
